# Manhole Inspection Summary

Manhole # S45A\_\_045MH

Insp Date: **6/11/08 9:40 AM**

**Location** Address: **Castle**

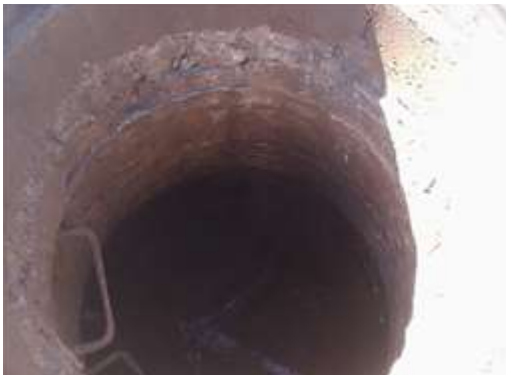
Defect 1

Infiltration: ☐ None ☐ Joint ☐ Cracks ☒ **Mortar** ☐ Roots ☐ Wall

Missing Mortar

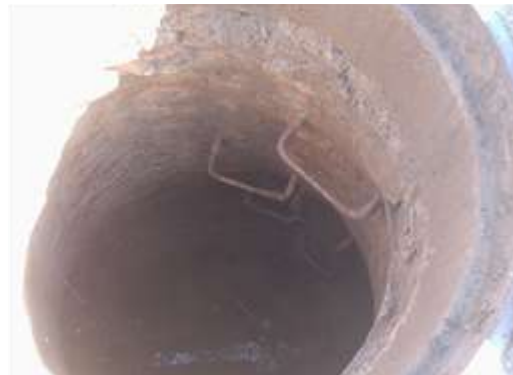
Defect 2

Condition: ☐ Sound ☐ Cracked ☐ Root Intrusion ☒ **Loose Brick** ☐ Deteriorated

Loose Brick

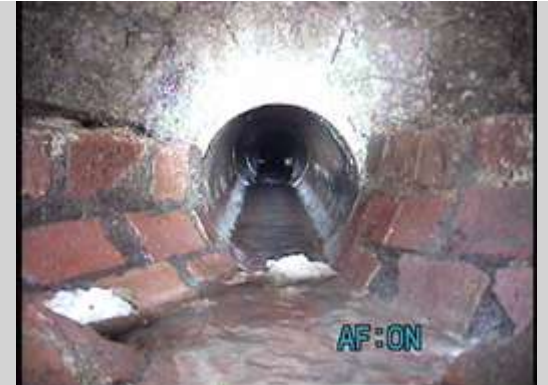
12 O'Clock Outflow

8 in. Circular Gravity Sewer  
Pipe Out @ 12 O'Clock

Pipe Height: **8.4** (in.) Rod and Bar (Angled)  
Pipe Material: **Clay** ☐ Pipe Lined  
Invert Depth: **10.25** (ft.) Flow Characteristics: **Fast**  
Deposits: ☒ None ☐ Mud ☐ Sludge ☐ Debris ☐ Grease  
Silt Depth: (in.) Deposits Extent:  
Infiltration: **None** Pipe Seal Cond: **Sound**

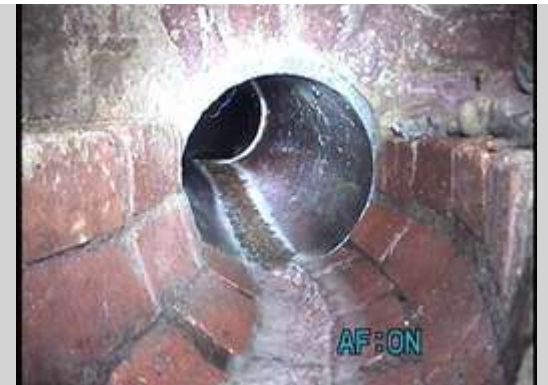
3 O'Clock Inflow

8 in. Circular Gravity Sewer  
Pipe In @ 3 O'Clock

Pipe Height: **8.4** (in.) Rod and Bar (Angled)  
Pipe Material: **Clay** ☐ Pipe Lined  
Invert Depth: **10.15** (ft.) Flow Characteristics: **Fast**  
Deposits: ☒ None ☐ Mud ☐ Sludge ☐ Debris ☐ Grease  
Silt Depth: (in.) Deposits Extent:  
Infiltration: **None** Pipe Seal Cond: **Sound**

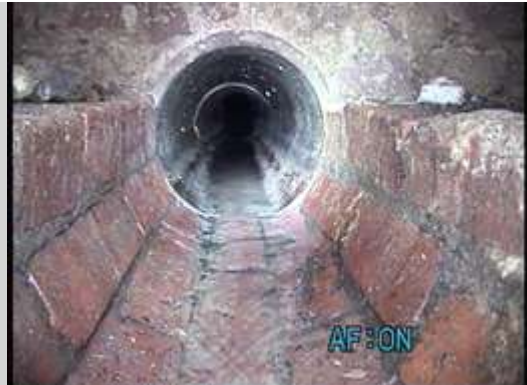
6 O'Clock Inflow

Pipe In @ 6 O'Clock

Infiltration: **None** Pipe Seal Cond: **Sound**

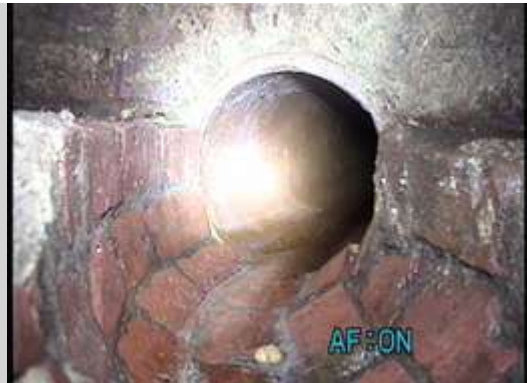
9 O'Clock Inflow

Pipe In @ 9 O'Clock

Infiltration: **None** Pipe Seal Cond: **Sound**
